PEMBROKE C. MK.1 WV.699

RADIO ACCEPTANCE TRIALS

8th Part of Report No. AAEE/896

23 FEB 1954

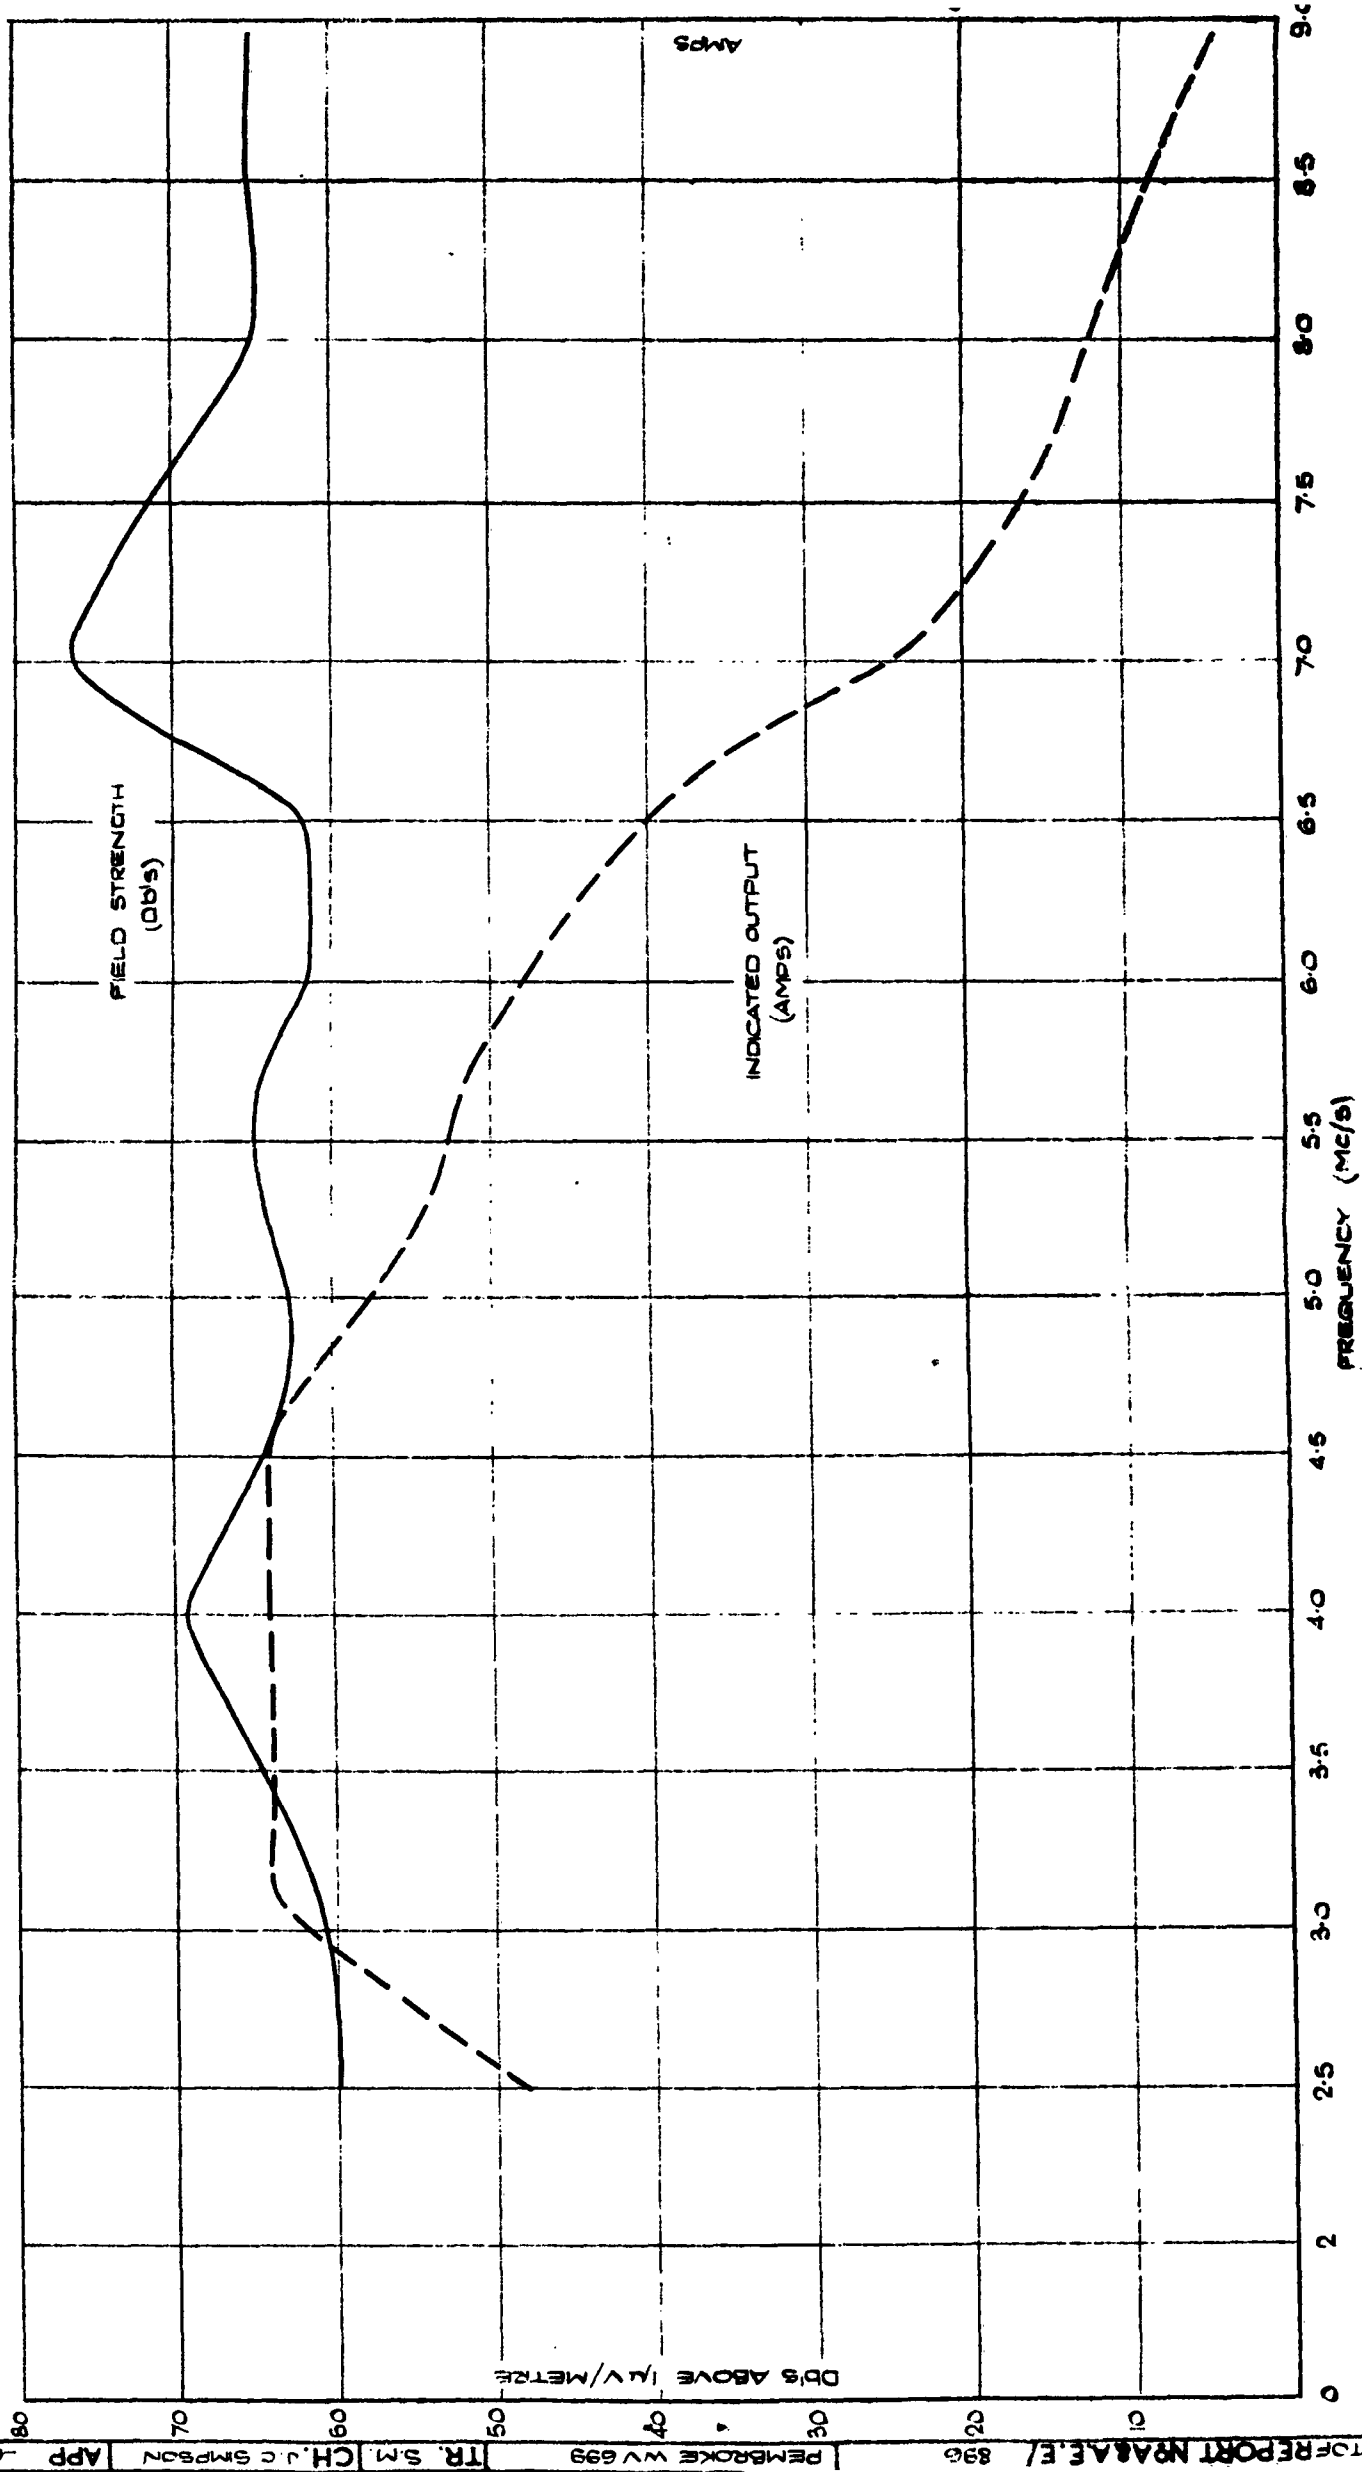
FIG. 17.

AD 97/108. FREQUENCY - FIELD STRENGTH, (MEASURED AT A DISTANCE OF 1500 YARDS.)
